practical CLASSICS

AGAINST ALL ODDS

Despite many setbacks Chris Starr has managed to steer his 1959 MGA through a successful rebuild and on to many concours victories — Chris Graham tells the story.

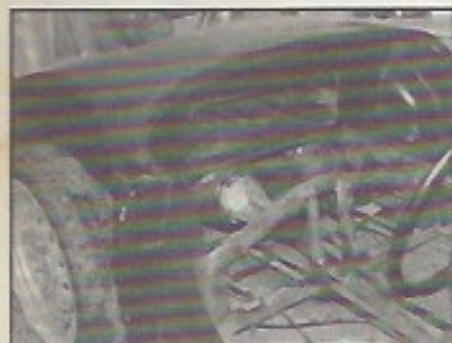
With the rear wings, the seats and the floor boards removed, Chris got the first inkling of the condition of the chassis. Some quite extensive repairs were required once the body had been removed.

To do this cuts were made through the badly corroded sills and, out of the 28 bolts that fastened the body to the chassis, Chris was amazed to find that only one was rusted solid. With the front half of the body removed the whole chassis was revealed and, as expected, holes were discovered. Chris had agreed to use a local body shop in which to carry out the restoration as he had no garage of his own at the time. This, of course, provided a very good working environment and made things a lot easier. The chassis was repaired with relative ease using a MIG welder but Chris admits that he didn't make the tidiest of jobs.

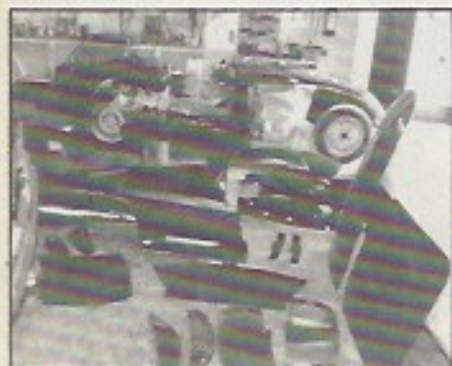
There were 21 separate items to be sprayed . . . and Chris was fortunate enough to have the use of professional equipment which helped greatly. However, little did he know that he would have to repeat the whole operation within a year.

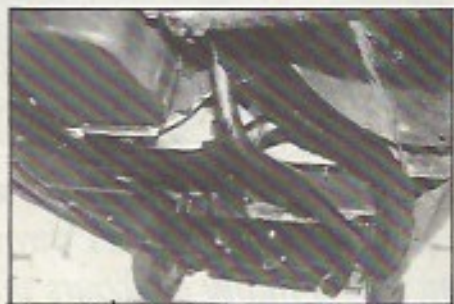
The underside has been kept as original as possible. Only those areas that do not show have been treated to any form of corrosion prevention and Chris relies on regular cleaning to stop the formation of rust on the untreated areas.
